**The World War II and Early Cold War Architectural Legacy
of Holloman Air Force Base (ca. 1942-1962)**

**by
Martyn D. Tagg**

**Holloman Air Force Base
Cultural Resources Publication No. 6**

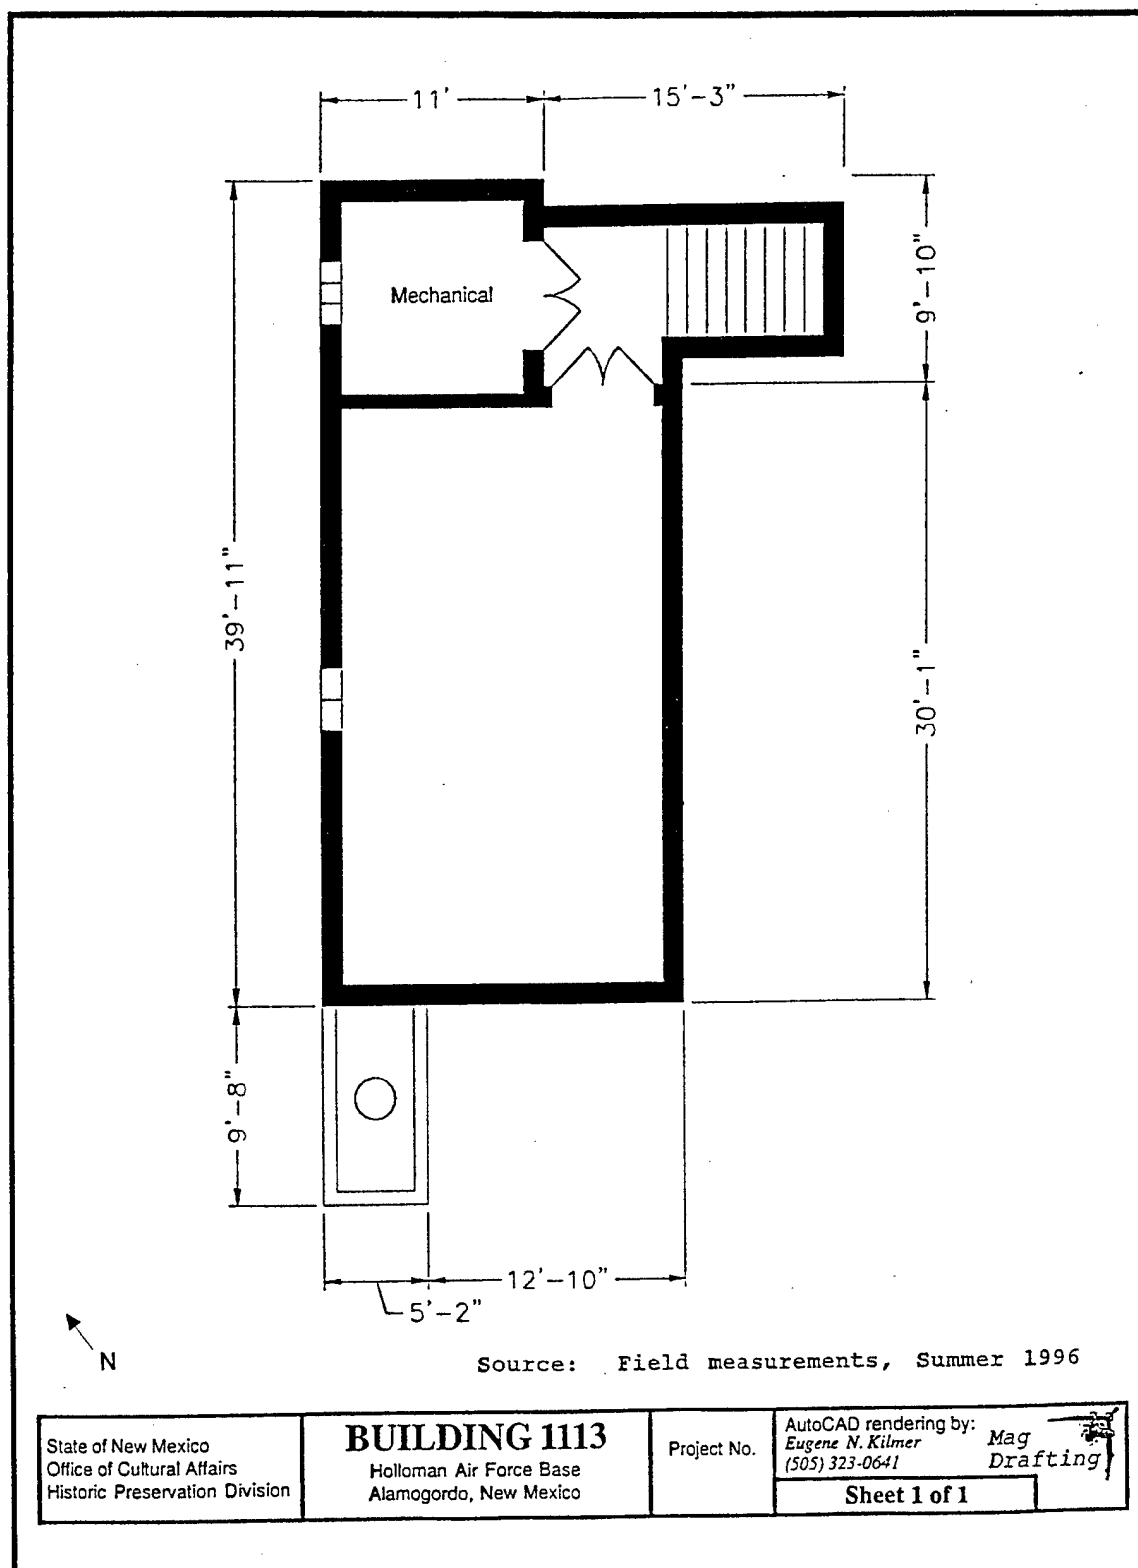
Figure 99. Building 1113, floor plan of a Timing-Communications Distribution Station, 1996.

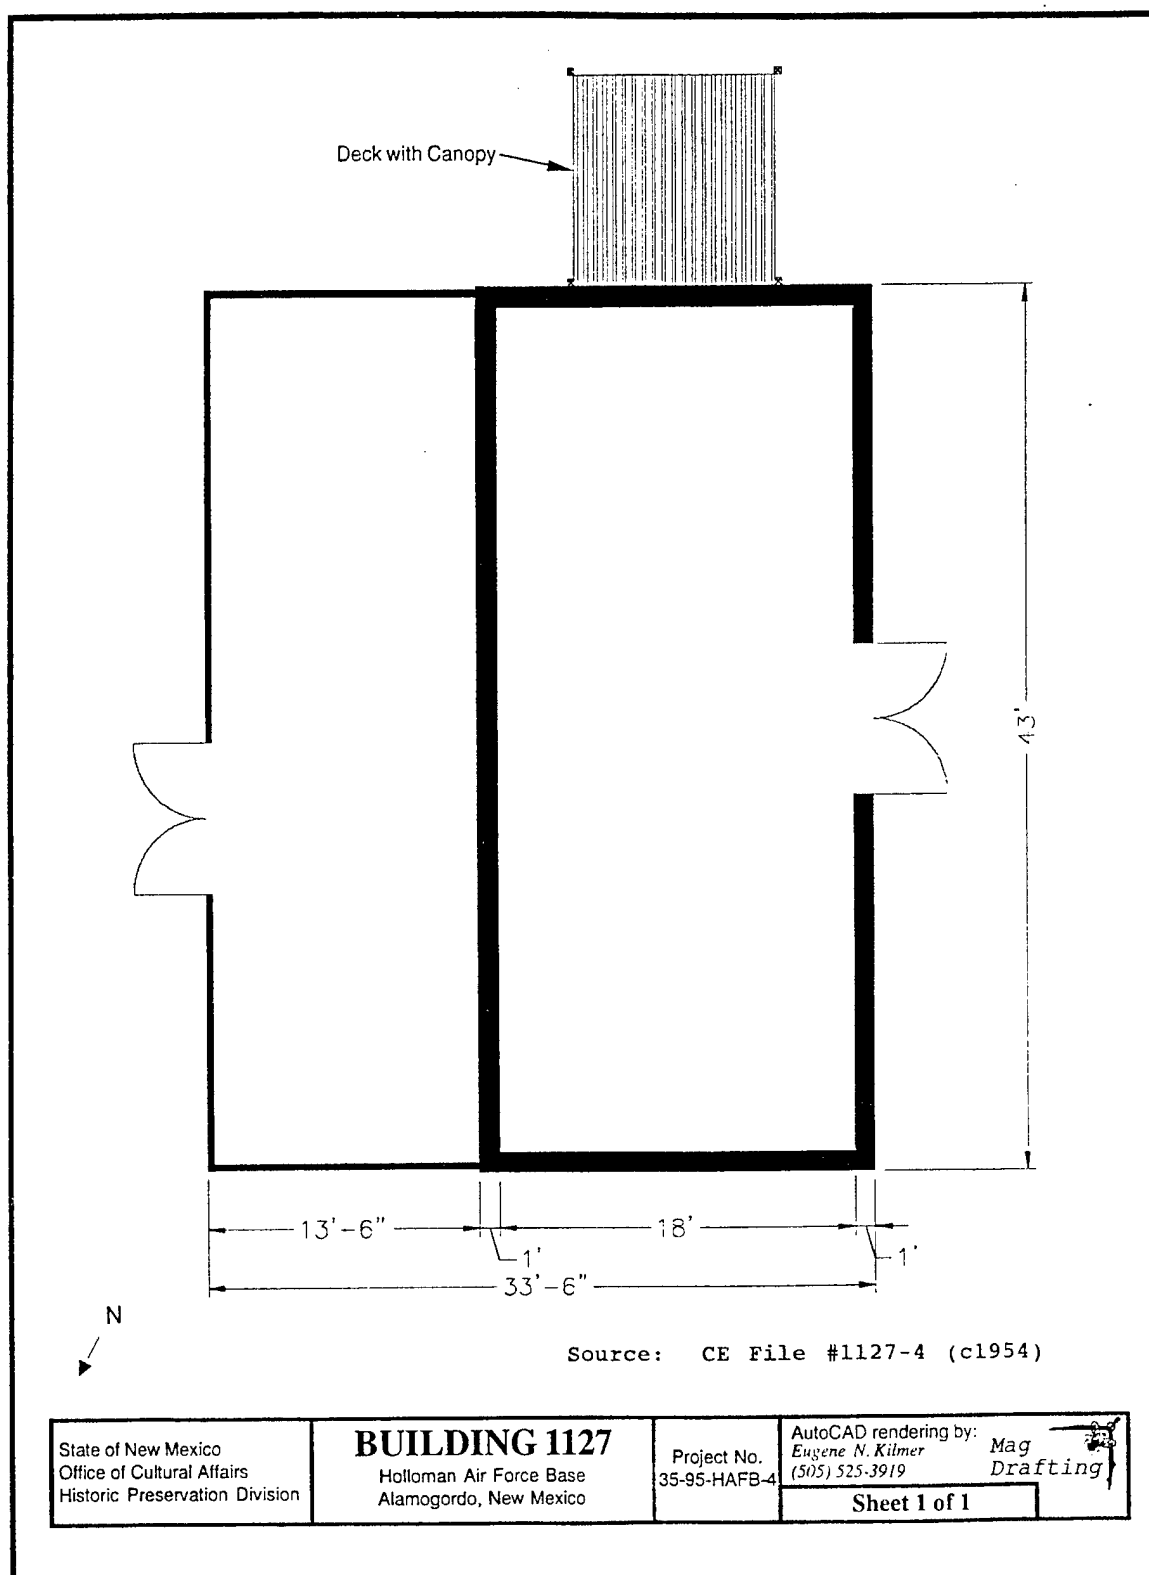
Figure 104. Building 1127, the Rocket Motor Conditioning facility, floor plan, ca. 1954.

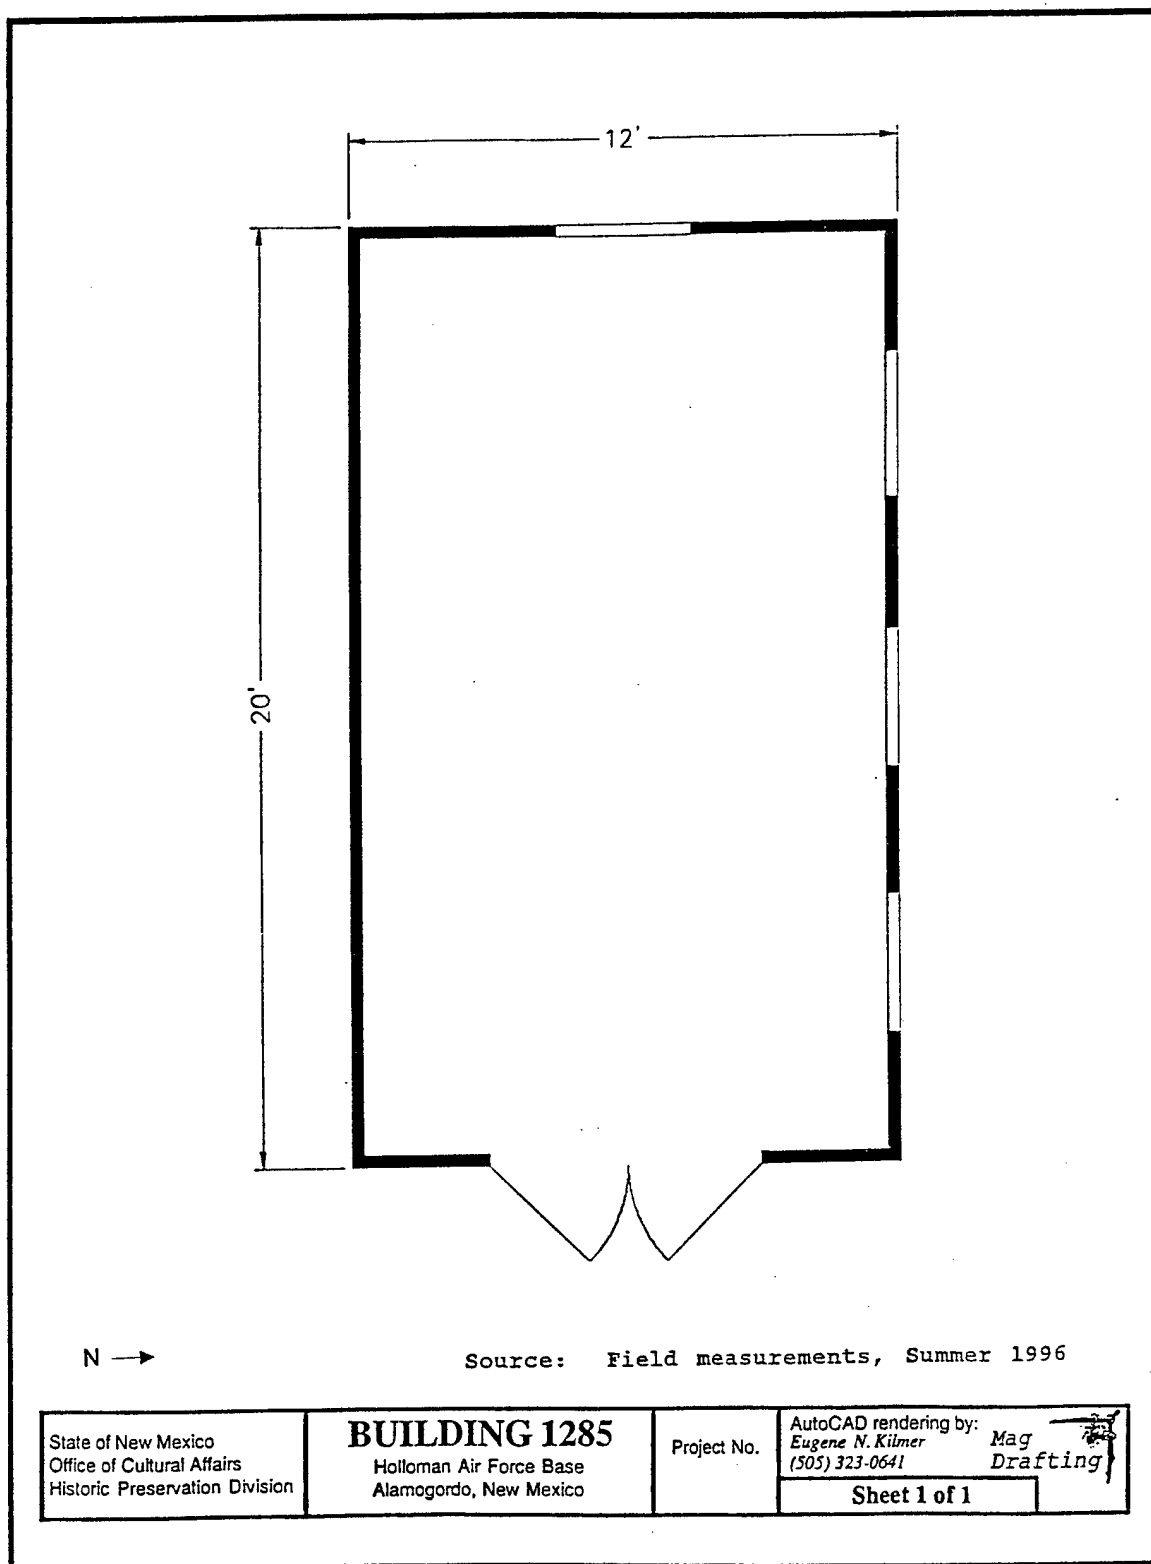
Figure 106. Building 1285, floor plan of Research Equipment Storage facility in 1996.

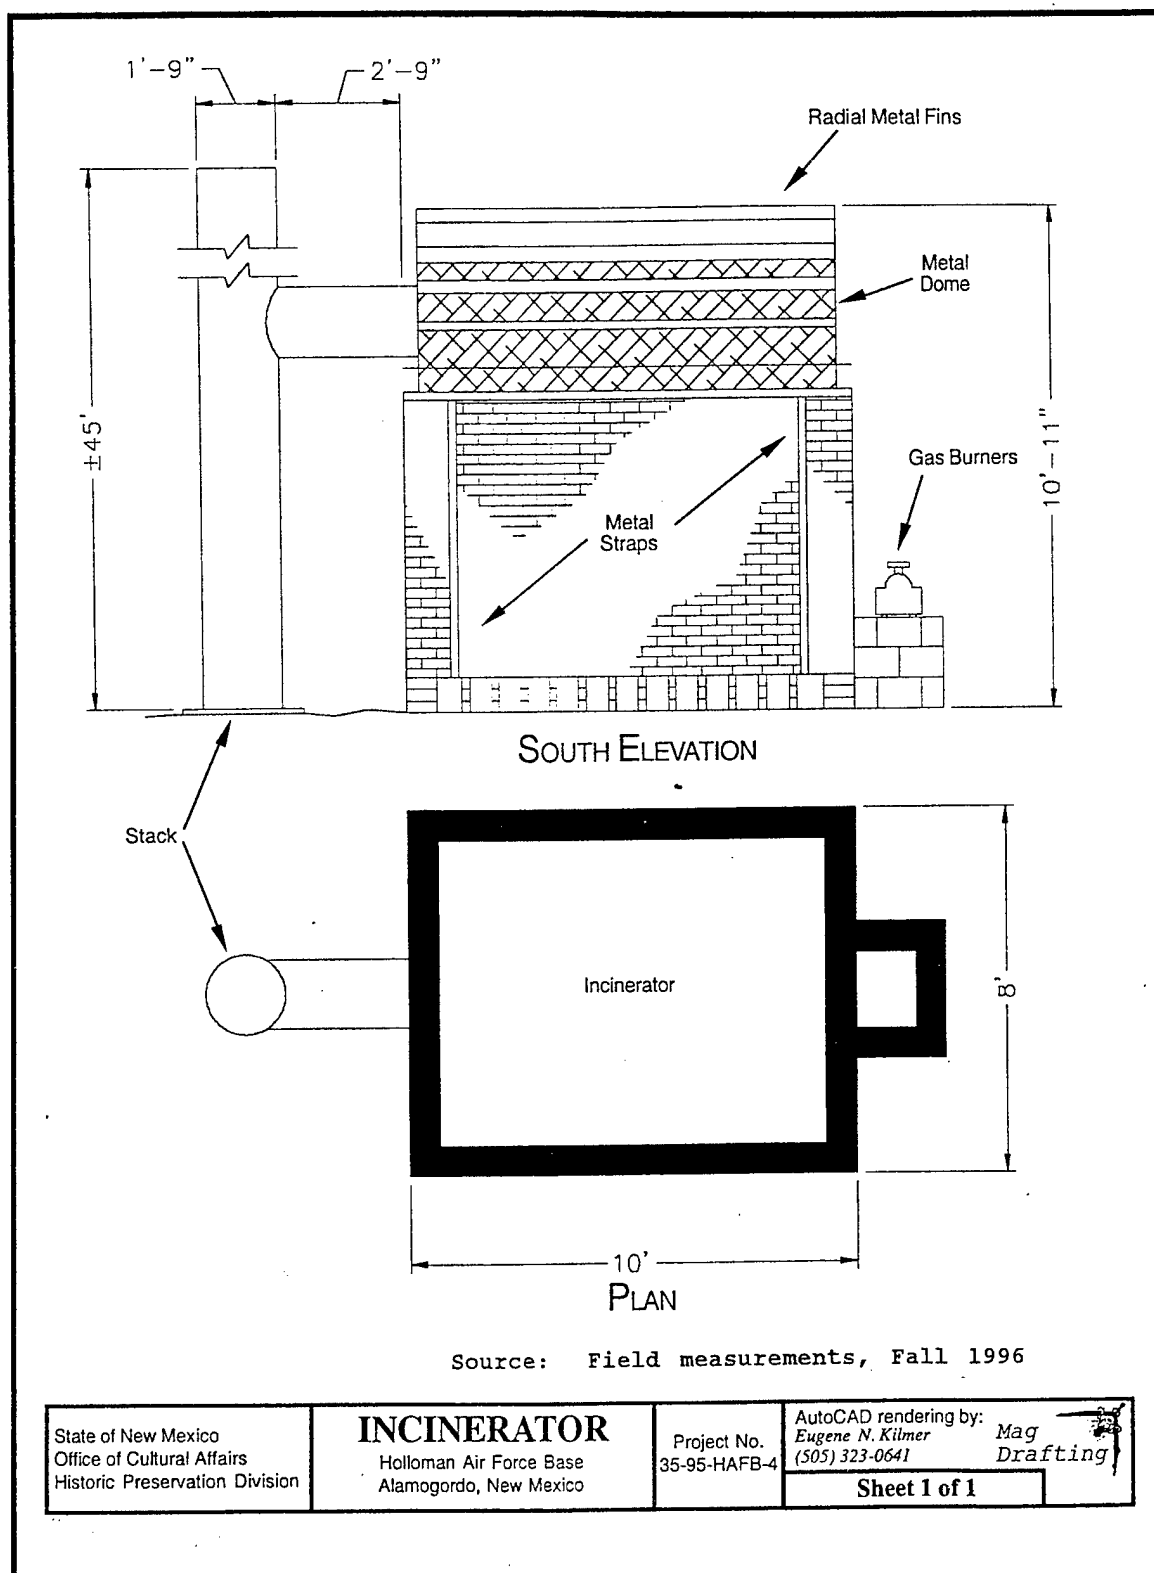
Figure 108. Incinerator, facility plan view and profile, 1996.
